AROSA – A first of its kind, and a well-maintained tanker

The AROSA is an excellent example of the benefits of a sound maintenance programme.

The world’s first double hull VLCC

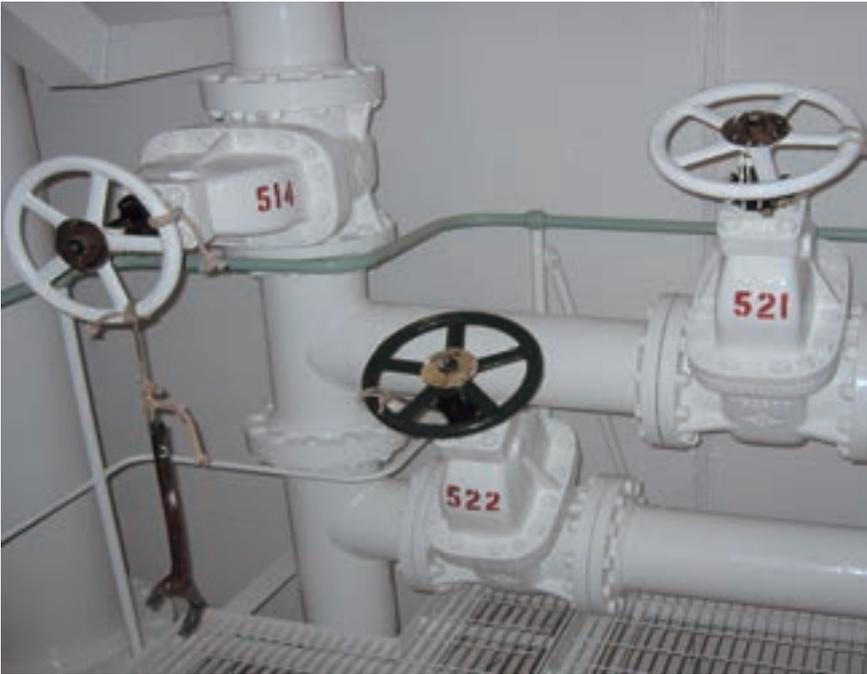
Valves in pump room: all clean, numbered and secured in position as indicated by rope attachment, turning bar close to hand.

All other areas of the vessel gave the same impression: cleanliness, efficient maintenance and good order. Tanker pump rooms normally have some oil stains and may be quite messy at the bottom. The AROSA’s pump room was totally clean and there was not even a smell of oil. Painted in white, the pump room gave more an impression of a hospital. The bottom plates were dry and clean, showing no sign of either oil or water. The engine room was the same, clean and without sign of leakages. Throughout the vessel no temporary solutions were seen, no patching up, no missing bolts, no leaking gaskets, no broken gear of any kind. The meaning of the expression “ship-shape” came to mind, as there was good order everywhere.

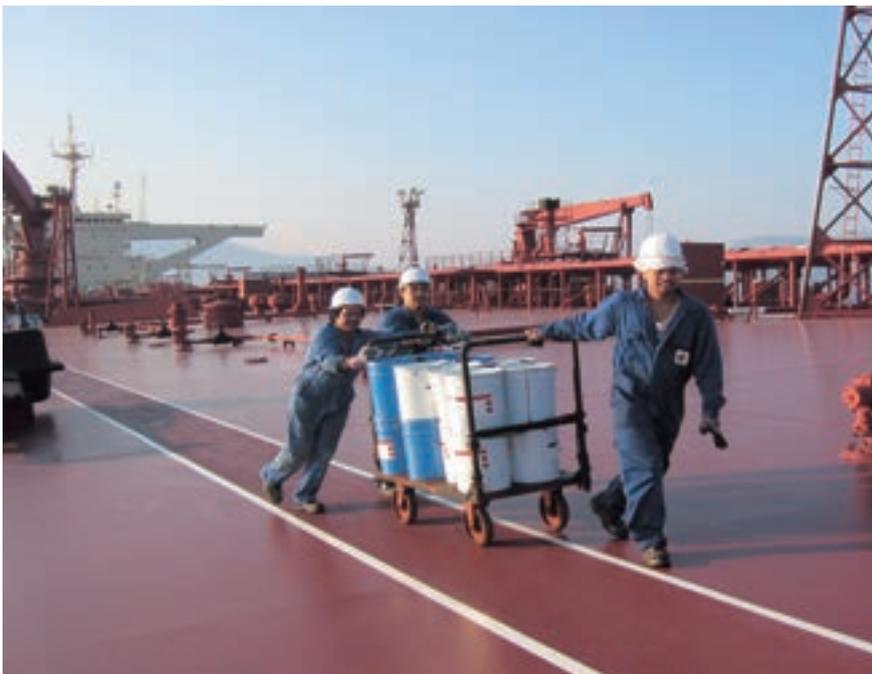
Crew members busy transporting tins of paint for maintaining the vessel. Note the marked lane with non-skid coating.

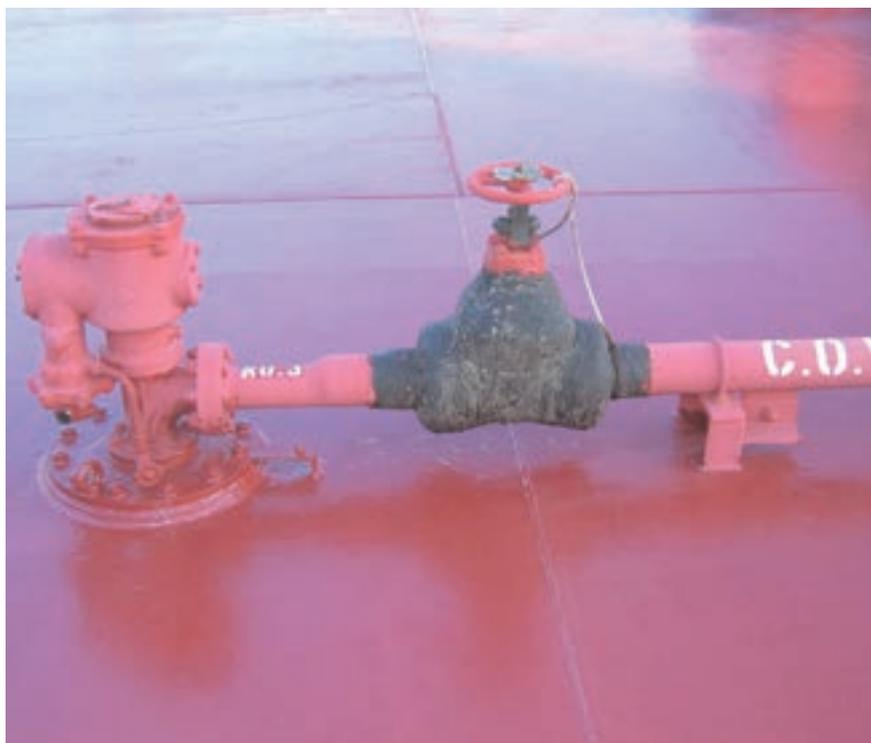
On deck all hawsers and wires on drums were noted to be covered by canvas, protected both against sunrays and sea spray. All pipelines were marked for last test and inspection, all valves were seen fitted with Denso wrapping, an expensive but efficient corrosion protection. Safe lanes for movements on deck were marked by white lines, all obstacles painted bright yellow. Anti-slip paint had been applied in all lanes and covered, for instance, the entire deck area in way of the anchor windlasses and mooring equipment forward.

Valves and flanges on deck are wrapped with Denso tape to avoid corrosion. The photo shows a deck valve in a crude oil washing line.
