TANKEROperator

JUNE 2008

A week in the life of a special VLCC

The world's first double hull VLCC recently completed her third special survey, following 15 years in service.*

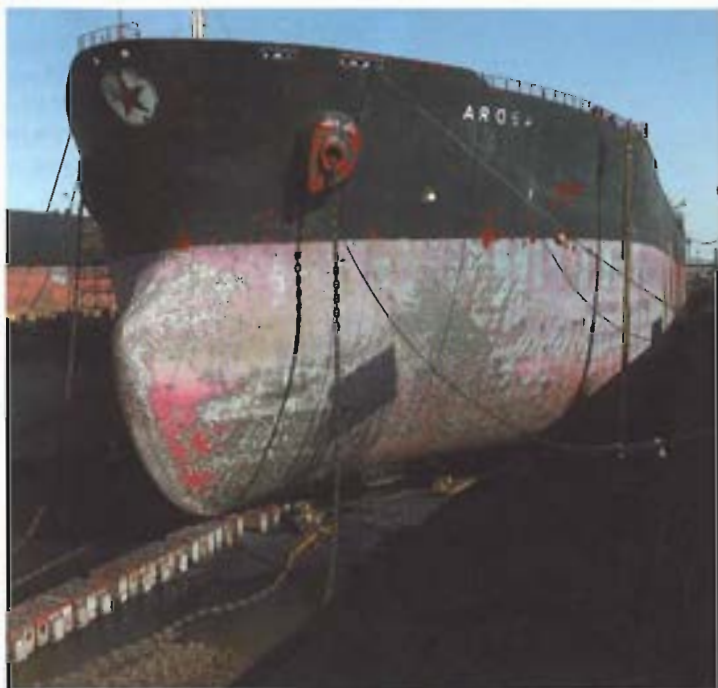
The *Arosa's* coatings were well maintained.

Vagliano also stressed the importance of looking after the coatings. He explained that six months after delivery, the coating systems fitters continuously worked on board *Arosa*, looking for blisters and upgrading an maintaining the coating. It was the chief officer's responsibility to monitor the inspections, which proved to be a never ending job.

While the vessel is in service, no uncoated areas are permitted. Every rusty edge is touched up as soon as it appears. This not only applied to the deck and deck fixtures, but also to the ballast and cargo tanks. When in a laden condition, the ballast tanks are regularly maintained.
