PRIDE IN DOING THINGS PROPERLY

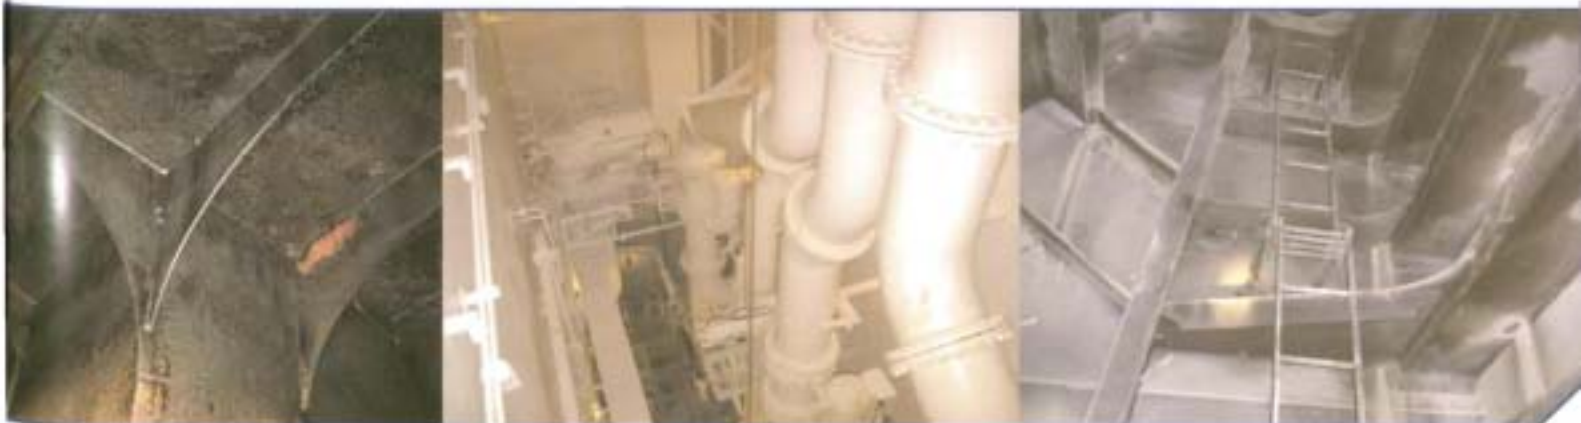
Inside a ballast tank it was the same story: no unpainted areas, not even a rusty edge. Of course there had been paint touch-ups as a result of regular maintenance, but there was no accumulation of mud and even the ladders were corrosion-free.

Inside *Arosa*'s cargo oil tank (left), engine room (centre), and water ballast tank (right) at 13 years of age.
